IN THE CORONERS COURT  
OF VICTORIA  
AT MELBOURNE

**FINDING INTO DEATH WITH INQUEST**

**Inquest into the Death of: PHILIP HARRISON**

Delivered On: 21 July 2015

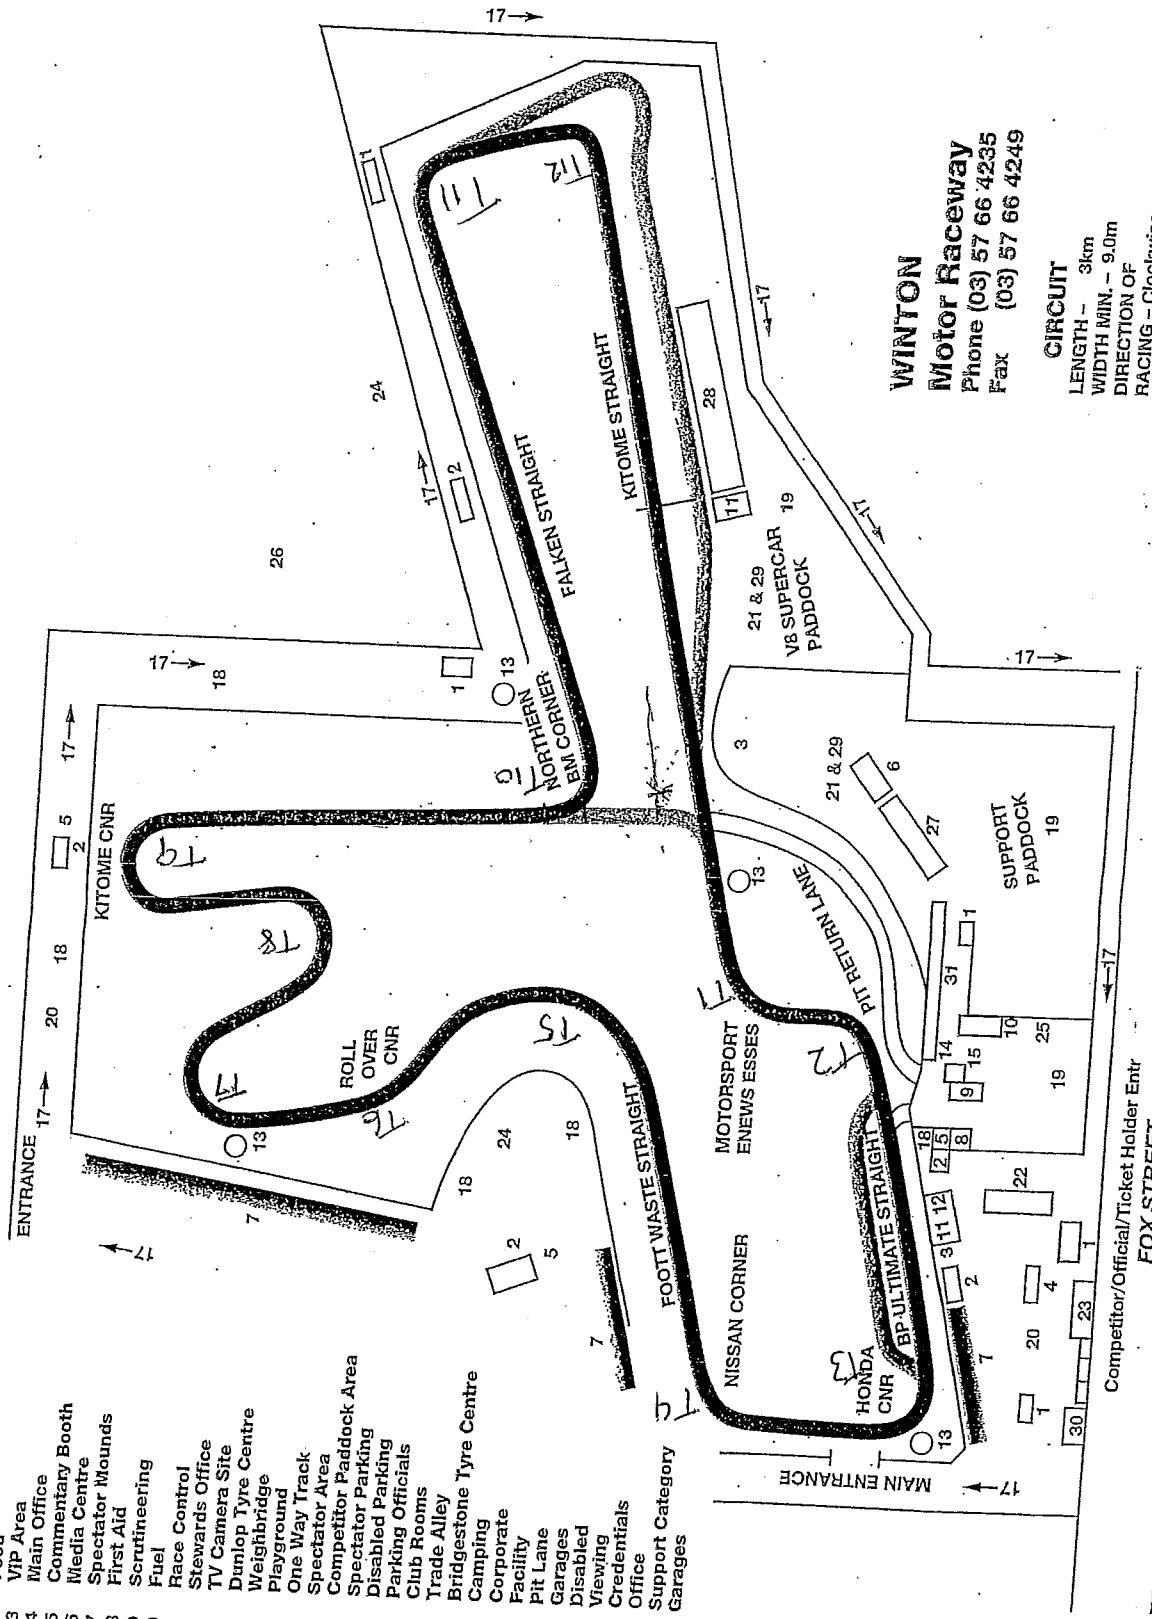
"A"

45. A diagram of the Winton circuit is attached to this Finding and marked as 'Attachment A'<sup>10</sup>.
46. The majority of activities at Winton are organised by third parties who hire the track. The track is mainly used for car racing and mainly in the long circuit configuration. The short circuit is used for motorcycle events, classic cars and tyre testing. There is a separate unsealed motor-cross track used for dirt bike racing which is not relevant to this investigation.

47. Both circuits are travelled in a clockwise direction. The short circuit has 10 corners and the long circuit has 12. Each corner is referred to by number, however the numbers differ depending on which circuit is used because the start lines are different. The long circuit corner numbers are shown in Attachment A with the markings 'T 1' to 'T 12'. Although Mr Harrison was racing the short circuit, for ease of reference I shall adopt the numbering in Attachment A.

52. It was into the tyre barrier that Mr Harrison and his motorcycle collided. The point of impact was approximately 4.5 m from the marked track edge.
53. A hand drawn single line in Attachment A shows the approximate position of the combined concrete wall and tyre barrier. The line is not to scale and is useful as a guide only. The mark 'X' indicates the approximate point of impact by Mr Harrison and his motorcycle.
