# Intersection of Spences Road and Numurkah Road, Katunga, Victoria

## Existing Conditions Road Safety Audit

Moira Shire Council

Final Report – 28/05/2019

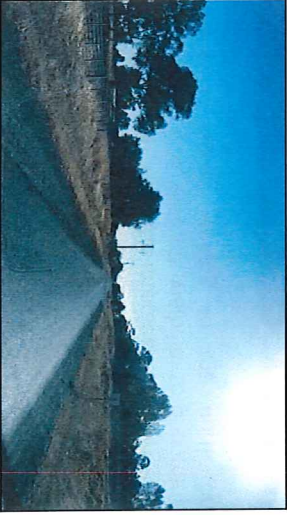
1.1.1.1	<p>When approaching the intersection from both approaches on Spences Road the location of Numurkah Road is hard to see due to a lack of identifying features and visual cues at the intersection. This may result in the approaching driver seeing through/past the intersection.</p> <p>This could result in a vehicle on Spences Road misjudging and overshooting the intersection, potentially colliding with a through vehicle on Numurkah Road.</p>	<p>Consider installing transverse rumble strips and associated warning signs on both Spences Road approaches.</p> <p>It is likely that the rumble strips will need to be installed for the full width of the road due to the narrow seal widths on both approaches.</p>	<p>Likelihood: Occasional</p> <p>Severity: Serious</p> <p><b>Risk Rating: HIGH</b></p>

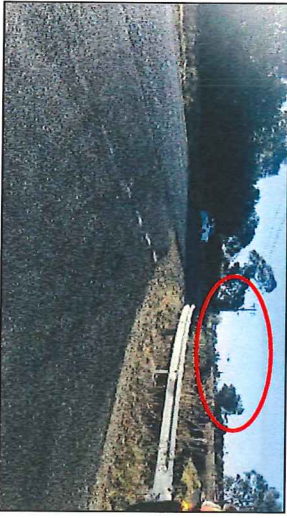
No	Audit Findings	Audit Recommendations	Risk Rating	Client Response Accept: Yes / No Reasons / Comments	
1.2	Intersections				
1.2.1	<p>There is vegetation around the irrigation farm channel (and associated infrastructure) on the northeast quadrant of the intersection behind the guard fence. This restricts visibility to oncoming vehicles of some looking to the north on Numurkah Road.</p>

<p>Trim/remove the vegetation in the northeast quadrant of the intersection to ensure sightlines are maintained.</p>	NOTE ONLY		
	<p>This could obscure a vehicle on the Numurkah Road northern approach from the view of a vehicle waiting to enter the intersection from the Spences Road eastern approach and could result in a collision between the two vehicles at the intersection.</p> <p>It should be noted that sightlines are in excess of 300 m looking north from the eastern approach at 5.0 m set back from the edge of seal on Numurkah Road.</p>

No	Audit Findings	Audit Recommendations	Risk Rating	Client Response Accept: Yes / No Reasons / Comments	
1.2.1 Cont.	<p>This is the desirable location from which to assess Safe Intersection Sight Distance (SISD) as specified in Figure 3.2 of AGRD4A.</p> <p>It is concluded that minimum SISD criterion is satisfied.</p> <p>However, to further ameliorate the risk of collisions at the intersection, some vegetation clearing is recommended.</p>	Refer above	Refer above

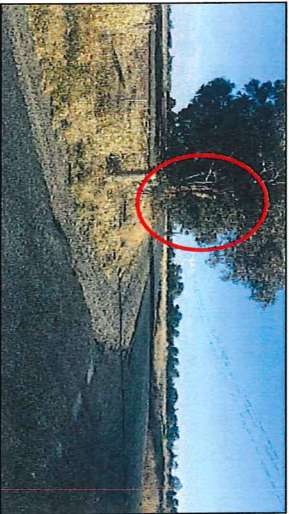
1.2.2	<p>There is a line of trees with low-hanging limbs that may restrict the vision of drivers on the eastern approach when looking south along Numurkah Road.</p> <p>This could obscure a vehicle on the Numurkah Road southern approach from the view of a vehicle waiting to enter the intersection from the Spences Road eastern approach and could result in a collision between the two vehicles at the intersection.</p>

No	Audit Findings	Audit Recommendations	Risk Rating	Accept: Yes / No	Client Response Reasons / Comments
1.2.2 Cont.	<p>It should be noted that sightlines are in excess of 300 m looking north from the eastern approach at 5.0 m set back from the edge of seal on Numurkah Road.</p> <p>This is the desirable location from which to assess Safe Intersection Sight Distance (SISD) as specified in Figure 3.2 of AGRD4A.</p> <p>It is concluded that the minimum SISD criterion is satisfied.</p> <p>However, to further ameliorate the risk of collisions at the intersection, some vegetation clearing is recommended.</p>	Refer above	Refer above

Trim/remove tree limbs on the eastern side of Numurkah Road (south of Spences Road) to ensure sightlines are maintained.	NOTE ONLY

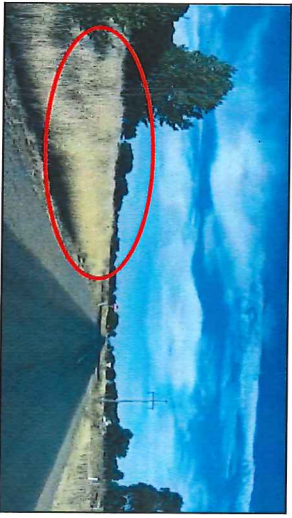
1.2.3	<p>Running parallel with Spences Road, on the north side of the road reserve is a 20 m to 25 m wide irrigation supply channel (including earth embankments).</p>

<p>This restricts the vision of drivers on the western approach when looking to the north along Numurkah Road.</p>	No action required	NOTE ONLY

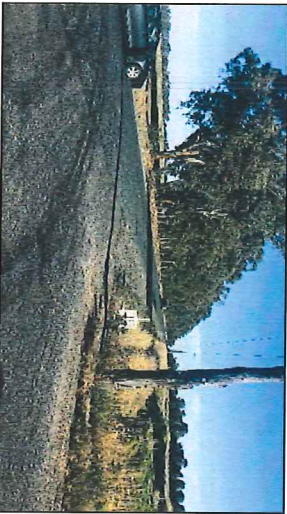
1.2.4	<p>There is a power pole on the south west corner of the intersection, however this does not impact the vision of drivers on the eastern approach when looking south along Numurkah Road.</p> <p>It should be noted that sightlines are in excess of 300 m looking south from the western approach at 5.0 m set back from the edge of seal on Numurkah Road.</p>	No action required	NOTE ONLY

<p>It is concluded that the minimum SISD criterion is satisfied</p>	Refer above	Refer above

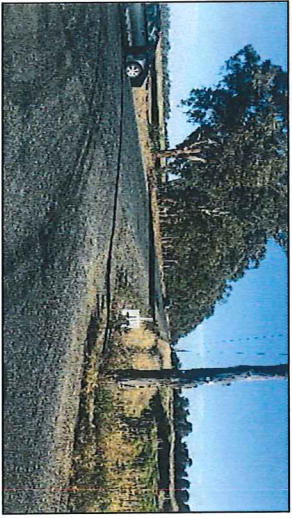
1.2.5	<p>The Spences Road western approach to Numurkah Road is STOP sign controlled.</p> <p>For a posted speed limit on the major road (Numurkah Road) of 100km/h the sight distance threshold along the major road (at 3.0m from the edge of the through lane) is 95m, below which a Stop sign should be used.</p> <p>The sightlines for Numurkah Road are more than 300m in both directions for the western approach indicating Give Way to be the appropriate control.</p> <p>The sight distance is greater than that shown in Figure 2.2 and therefore, a STOP sign is not required.</p>	Review the appropriateness of the STOP sign on the Spences Road west approach with a view to replacing it with a GIVE WAY sign, and markings.	NOTE ONLY

No	Audit Findings	Audit Recommendations	Risk Rating	Client Response Accept: Yes / No Reasons / Comments	
1.2.5 Cont.	<p>Spences Road looking south (western approach).</p>

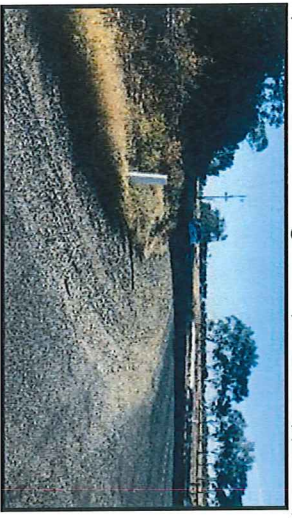
<p>Spences Road looking north (western approach).</p>

<p>It should be noted that the use of STOP signs where poor sight distance is not a factor can lead to driver non-compliance, and a lack of credibility of STOP signs where they are appropriate.</p>	Refer above	Refer above

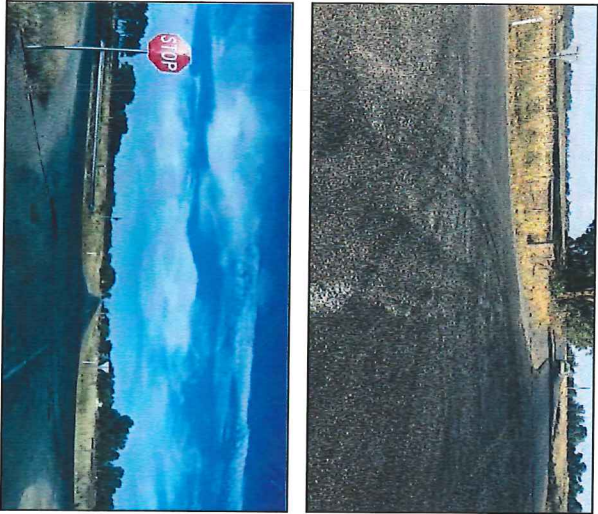
No	Audit Findings	Audit Recommendations	Risk Rating	Client Response Accept: Yes / No Reasons / Comments	
1.2.6	<p>The STATCON line marking at the intersection is faded and does not delineate the intersection. This makes it hard to see when approaching the intersection from both approaches on Spences Road.</p> <p>This could result in a vehicle on Spences Road misjudging the intersection and overshooting, potentially colliding with through traffic on Numurkah Road.</p>

<p>Refresh all the STATCON linemarking at the intersection following the review noted in Item 1.2.4.</p>	<p>Likelihood: Improbable Severity: Serious Risk Rating: <b>MEDIUM</b></p>

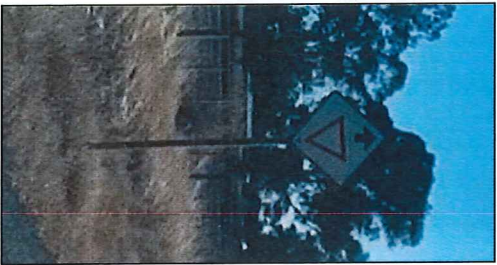
1.3.2	<p>Advance warning signs on both minor approaches are faded and are in poor condition.</p> <p>This could make it difficult for an approaching driver to clearly read and comprehend the message the sign is displaying.</p> <p>This may result in the driver misjudging the intersection and overshooting, potentially colliding with through traffic on Numurkah Road.</p>	<p>Replace the signs and consider installing a duplicate on the opposite side of Spences Road.</p>	<p>Likelihood: Improbable</p> <p>Severity: Serious</p> <p>Risk Rating: MEDIUM</p>

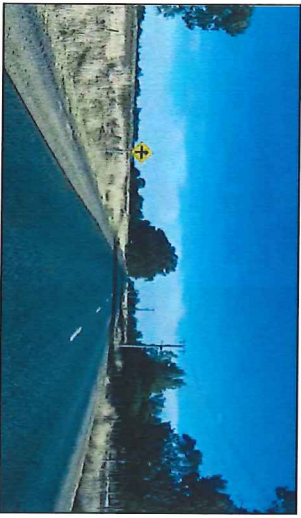
No	Audit Findings	Audit Recommendations	Risk Rating	Client Response Accept: Yes / No Reasons / Comments	
1.3.3	<p>Crossroad warning signs are present on both major approaches and are in good condition.</p> <p>Northern Approach</p>

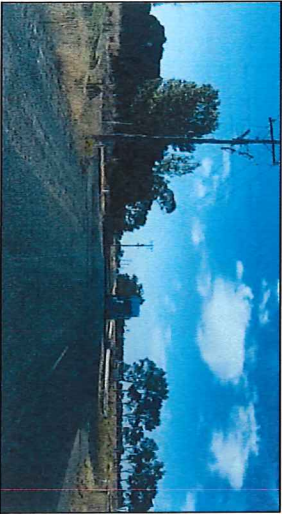
No	Audit Findings	Audit Recommendations	Risk Rating	Client Response Accept: Yes / No Reasons / Comments	
1.4	<b>Markings and Delineation</b>				
1.4.1	<p>Numurkah Road only has a centreline marked in the vicinity of the Spencer Road intersection. At the intersection this centre line is faded.</p>

<p>Refresh the centre line along Numurkah Road through the intersection and consider the installation of edgelines.</p>	<p>Likelihood: Improbable Severity: Minor Risk Rating: LOW</p>

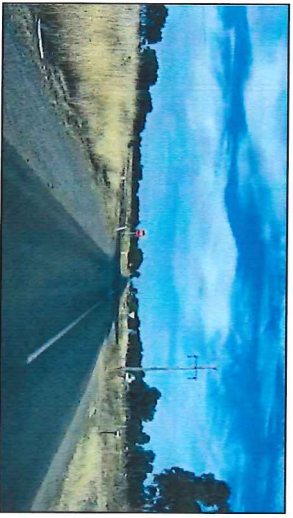
1.4.2	<p>The narrow seal of Spences Road precludes the installation of longitudinal line markings, apart from the single continuous dividing line at the approach to the STATCON markings at each yield point.</p> <p>The single continuous dividing line marking at the intersection is faded, reducing visibility of the intersection, particularly in dark and inclement weather conditions on the western approach.</p>	<p>Refresh the single continuous dividing line to the STATCON markings on the western minor approach.</p>	<p>Likelihood: Improbable Severity: Serious Risk Rating: MEDIUM</p>

No	Audit Findings	Audit Recommendations	Risk Rating	Client Response Accept: Yes / No Reasons / Comments	
1.4.2 Cont.	<p>This could result in a vehicle on Spences Road misjudging the intersection and overshooting, potentially colliding with through traffic on Numurkah Road.</p>

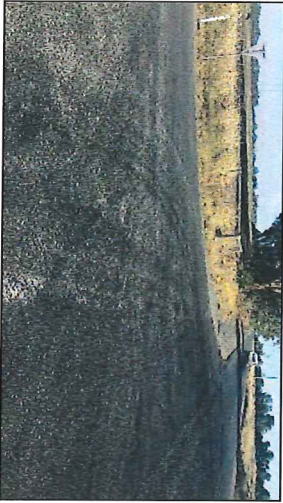
Refer above	Refer above		
1.4.3	<p>Near the intersection along both Spencer Road and Numurkah Road, guideposts are only installed to mark cross culverts and other roadside structures.</p>

<p>Guide posts are used to mark the edge of the road formation in the absence of other features, such as edgelines, guard fence or bridge rail.</p>	Consider installing additional guideposts on the approaches to the Spencer Road/Numurkah Road intersection to enhance delineation of the intersection.	<p>Likelihood: Improbable Severity: Minor Risk Rating: LOW</p>

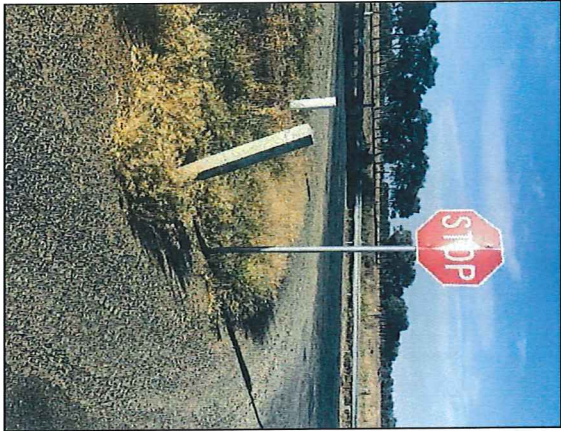
No	Audit Findings	Audit Recommendations	Risk Rating	Client Response Accept: Yes / No Reasons / Comments	
1.4.3 Cont.	Guideposts delineate the road edge and assist the road user by indicating the alignment of the road ahead and under some circumstances, by providing a gauge with which to assess available sight distance.	Refer above	Refer above		
<b>1.5 Crash Barrier and Clear Zones</b>					
1.5.1	Located near the Stop sign on the western approach to Nurnurkah Road is an obsolete (old style) guidepost. This is not considered frangible and present a hazard to an errant vehicle on the western approach to the intersection.	Remove the obsolete guidepost and replace it with a frangible guidepost as required.	Likelihood: Improbable Severity: Minor Risk Rating: LOW

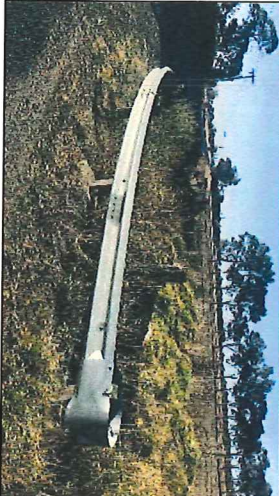
No	Audit Findings	Audit Recommendations	Risk Rating	Client Response Accept: Yes / No Reasons / Comments	
1.5.2	<p>Type-B Guard Fence exists on the north east quadrant of the intersection shielding the farm channel infrastructure.</p> <p>A redundant fence post is located behind the southern barrier terminal.</p>

<p>The existing barrier does not protect the fence post at the location as it is located behind the gating terminal, which provides an inadequate length (of need) for the safety barrier.</p> <p>Should an errant vehicle run-off the road at this location, the barrier will not shield this hazard as intended.</p> <p>The safety barrier installation does not conform to current guidelines.</p>	<p>Consider the following course of action (in order of priority):</p> <ol style="list-style-type: none"> <li>1. remove the hazard (post)</li> <li>2. mitigate the residual risk (i.e. shield remaining roadside hazards with a compliant safety barrier system as required, replacing the existing non-conforming system).</li> </ol>	<p>Likelihood: Improbable</p> <p>Severity: Serious</p> <p><b>Risk Rating: MEDIUM</b></p>

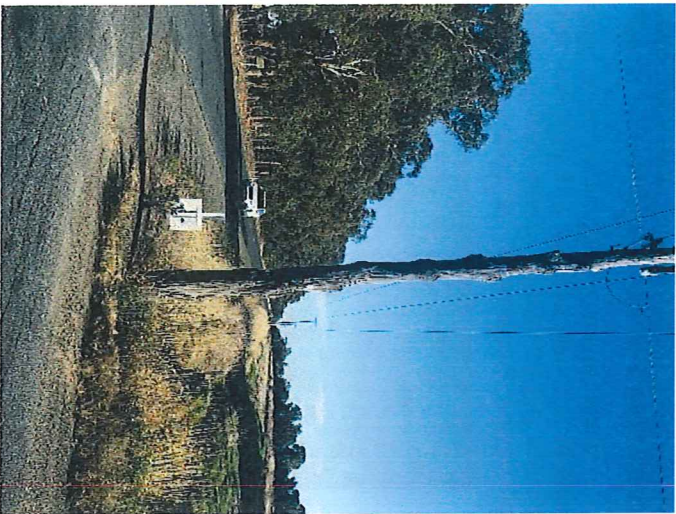
No	Audit Findings	Audit Recommendations	Risk Rating	Client Response Accept: Yes / No Reasons / Comments	
1.5.3	<p>There is a power pole located on the south west quadrant of the intersection, at a 2.2 m offset from the edge of seal.</p>

<p>This is considered a hazard should an errant vehicle run-off the road at this location.</p>	<p>Consider the following course of action (in order of priority):</p> <ol style="list-style-type: none"> <li>1. remove / relocate the power pole</li> <li>2. mitigate the residual risk by shielding the pole</li> </ol>	<p>Likelihood: Occasional Severity: Serious Risk Rating: <b>HIGH</b></p>

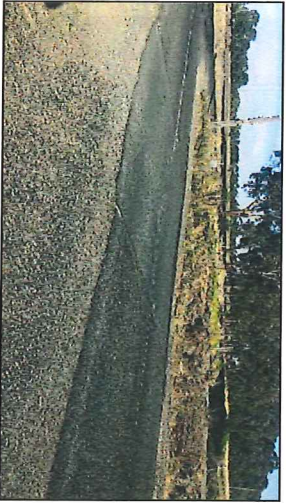
No	Audit Findings	Audit Recommendations	Risk Rating	Client Response Accept: Yes / No Reasons / Comments	
1.6	Pavement				
1.6.1	<p>It appears the pavement is falling on the western approach to the intersection at the location of the channel crossing/syphon under Spencer Road.</p> <p>This has resulted in a depression occurring in the road formation within the braking zone at the approach to the intersection.</p>

<p>This may cause an approaching eastbound vehicle to lose control, or impede the braking ability, resulting in a collision with a road side hazard or another vehicle at the intersection.</p> <p>It should be noted that there was evidence of maintenance spray paint reference markings on the road pavement at the depression, potentially indicating an intension to address this pavement depression.</p>	Repair the road pavement.	<p>Likelihood: Occasional</p> <p>Severity: Serious</p> <p><b>Risk Rating: HIGH</b></p>
