Intersection of Spences Road and Numurkah Road, Katunga, Victoria

Existing Conditions Road Safety Audit

Moira Shire Council

Final Report – 28/05/2019

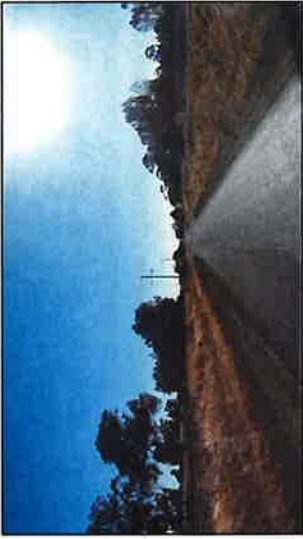
1.1.1	<p>When approaching the intersection from both approaches on Spences Road the location of Numurkah Road is hard to see due to a lack of identifying features and visual cues at the intersection. This may result in the approaching driver seeing through/past the intersection.</p> <p>This could result in a vehicle on Spences Road misjudging and overshooting the intersection, potentially colliding with a through vehicle on Numurkah Road.</p>

<p>Consider installing transverse rumble strips and associated warning signs on both Spences Road approaches.</p> <p>It is likely that the rumble strips will need to be installed for the full width of the road due to the narrow seal widths on both approaches.</p>	<p>Likelihood: Occasional</p> <p>Severity: Serious</p> <p>Risk Rating: HIGH</p>	Yes

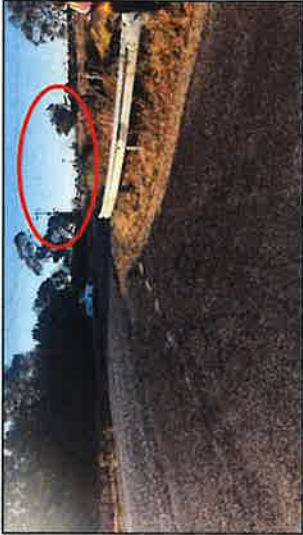
No	Audit Findings	Audit Recommendations	Risk Rating	Accept: Yes / No	Client Response Reasons / Comments
1.2	Intersections				
1.2.1	<p>There is vegetation around the irrigation farm channel (and associated infrastructure) on the northeast quadrant of the intersection behind the guard fence. This restricts visibility to oncoming vehicles of some looking to the north on Numurkah Road.</p>

<p>This could obscure a vehicle on the Numurkah Road northern approach from the view of a vehicle waiting to enter the intersection from the Spences Road eastern approach and could result in a collision between the two vehicles at the intersection.</p> <p>It should be noted that sightlines are in excess of 300 m looking north from the eastern approach at 5.0 m set back from the edge of seal on Numurkah Road.</p>	Trim/remove the vegetation in the northeast quadrant of the intersection to ensure sightlines are maintained.	NOTE ONLY	Yes	Only for vegetation within the road reserve. Vegetation within the channel reserve is the responsibility of Goulburn Murray Water (GMW)

No	Audit Findings	Audit Recommendations	Risk Rating	Accept: Yes / No	Client Response Reasons / Comments
1.2.1 Cont.	<p>This is the desirable location from which to assess Safe Intersection Sight Distance (SISD) as specified in Figure 3.2 of AGRD4A.</p> <p>It is concluded that minimum SISD criterion is satisfied.</p> <p>However, to further ameliorate the risk of collisions at the intersection, some vegetation clearing is recommended.</p>	Refer above	Refer above

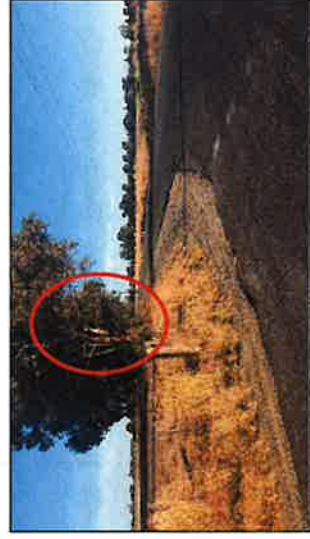
1.2.2	<p>There is a line of trees with low-hanging limbs that may restrict the vision of drivers on the eastern approach when looking south along Numurkah Road.</p> <p>This could obscure a vehicle on the Numurkah Road southern approach from the view of a vehicle waiting to enter the intersection from the Spences Road eastern approach and could result in a collision between the two vehicles at the intersection.</p>	Trim/remove tree limbs on the eastern side of Numurkah Road (south of Spences Road) to ensure sightlines are maintained.	NOTE ONLY	Yes

No	Audit Findings	Audit Recommendations	Risk Rating	Accept: Yes / No	Client Response Reasons / Comments
1.2.2 Cont.	<p>It should be noted that sightlines are in excess of 300 m looking north from the eastern approach at 5.0 m set back from the edge of seal on Numurkah Road.</p> <p>This is the desirable location from which to assess Safe Intersection Sight Distance (SISD) as specified in Figure 3.2 of AGRD4A.</p> <p>It is concluded that the minimum SISD criterion is satisfied.</p> <p>However, to further ameliorate the risk of collisions at the intersection, some vegetation clearing is recommended.</p>	Refer above	Refer above

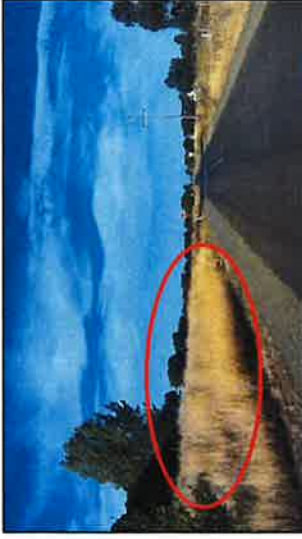
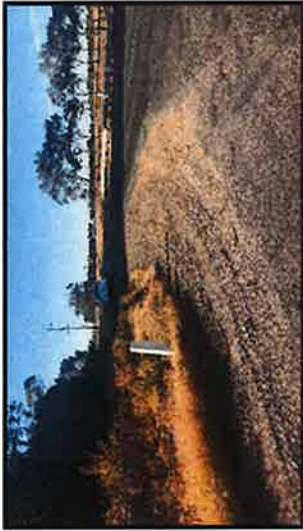
1.2.3	<p>Running parallel with Spences Road, on the north side of the road reserve is a 20 m to 25 m wide irrigation supply channel (including earth embankments).</p>

<p>This restricts the vision of drivers on the western approach when looking to the north along Numurkah Road.</p>	No action required	NOTE ONLY

No	Audit Findings	Audit Recommendations	Risk Rating	Accept: Yes / No	Client Response Reasons / Comments
1.2.3 Cont.	<p>However, it should be noted that sightlines are in excess of 300 m looking north from the western approach at 5.0 m set back from the edge of seal on Numurkah Road.</p> <p>This is the desirable location from which to assess Safe Intersection Sight Distance (SISD) as specified in Figure 3.2 of AGRD4A.</p>

<p>It is concluded that the minimum SISD criterion is satisfied</p>	Refer above	Refer above

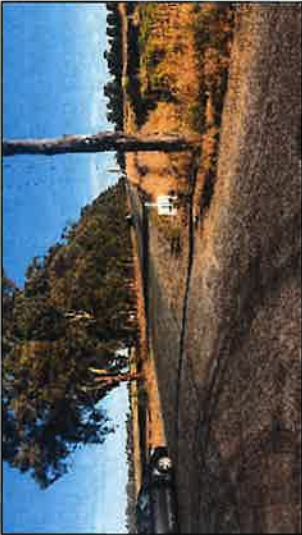
1.2.4	<p>There is a power pole on the south west corner of the intersection, however this does not impact the vision of drivers on the eastern approach when looking south along Numurkah Road.</p> <p>It should be noted that sightlines are in excess of 300 m looking south from the western approach at 5.0 m set back from the edge of seal on Numurkah Road.</p>	No action required	NOTE ONLY

<p>It is concluded that the minimum SISD criterion is satisfied</p>	Refer above	Refer above

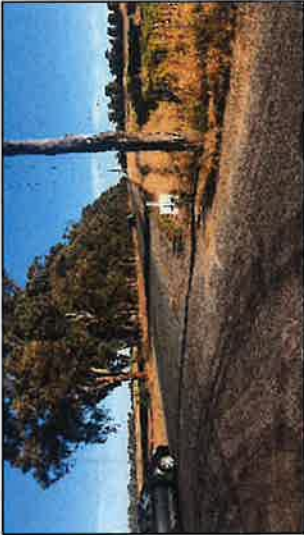
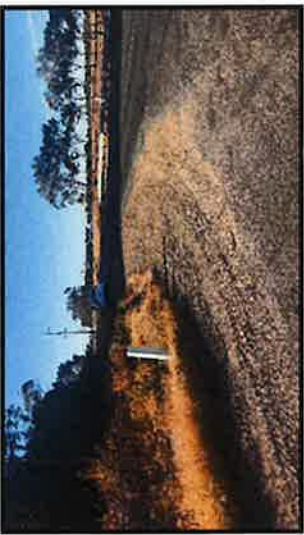
1.2.5	<p>The Spences Road western approach to Numurkah Road is STOP sign controlled.</p> <p>For a posted speed limit on the major road (Numurkah Road) of 100km/h the sight distance threshold along the major road (at 3.0m from the edge of the through lane) is 95m, below which a Stop sign should be used.</p> <p>The sightlines for Numurkah Road are more than 300m in both directions for the western approach indicating Give Way to be the appropriate control.</p> <p>The sight distance is greater than that shown in Figure 2.2 and therefore, a STOP sign is not required.</p>	Review the appropriateness of the STOP sign on the Spences Road west approach with a view to replacing it with a GIVE WAY sign, and markings.	NOTE ONLY	Yes	The review will be conducted with results tabled at the Council's Local Traffic Committee for its consideration. Next Committee meeting is scheduled for September 2019.

No	Audit Findings	Audit Recommendations	Risk Rating	Accept: Yes / No	Client Response Reasons / Comments
1.2.5 Cont.	<p>Spences Road looking south (western approach).</p>

<p>Spences Road looking north (western approach).</p>

<p>It should be noted that the use of STOP signs where poor sight distance is not a factor can lead to driver non-compliance, and a lack of credibility of STOP signs where they are appropriate.</p>	Refer above	Refer above

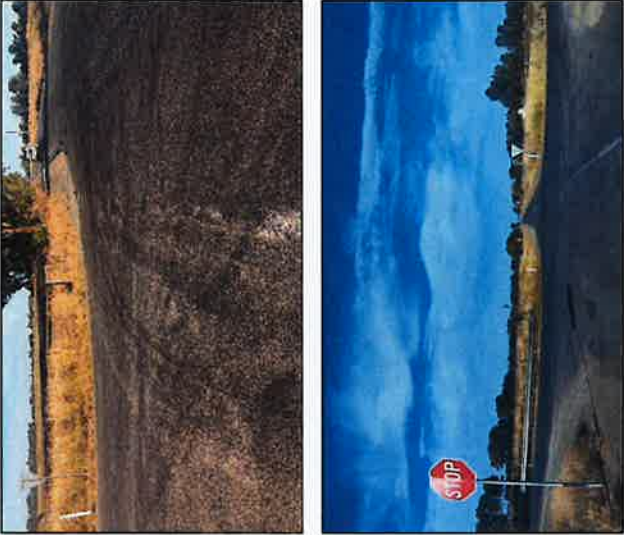
No	Audit Findings	Audit Recommendations	Risk Rating	Accept: Yes / No	Client Response Reasons / Comments
1.2.6	<p>The STATCON line marking at the intersection is faded and does not delineate the intersection. This makes it hard to see when approaching the intersection from both approaches on Spences Road.</p> <p>This could result in a vehicle on Spences Road misjudging the intersection and overshooting, potentially colliding with through traffic on Numurkah Road.</p>

Refresh all the STATCON linemarking at the intersection following the review noted in item 1.2.4.	<p>Likelihood: Improbable</p> <p>Severity: Serious</p> <p>Risk Rating: MEDIUM</p>	Yes

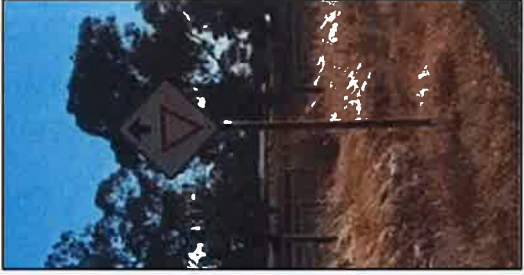
1.3.2	<p>Advance warning signs on both minor approaches are faded and are in poor condition.</p> <p>This could make it difficult for an approaching driver to clearly read and comprehend the message the sign is displaying.</p> <p>This may result in the driver misjudging the intersection and overshooting, potentially colliding with through traffic on Numurkah Road.</p>

<p>Replace the signs and consider installing a duplicate on the opposite side of Spences Road.</p>	<p>Likelihood: Improbable</p> <p>Severity: Serious</p> <p>Risk Rating: MEDIUM</p>	Yes

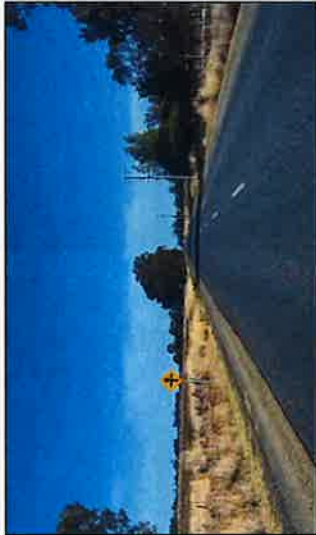
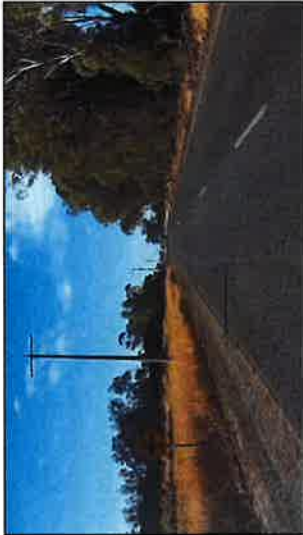
No	Audit Findings	Audit Recommendations	Risk Rating	Accept: Yes / No	Client Response Reasons / Comments
1.3.3	<p>Crossroad warning signs are present on both major approaches and are in good condition.</p> <p>Northern Approach</p>

<p>Southern Approach</p>

<p>No further action required.</p>	No action required	NOTE ONLY

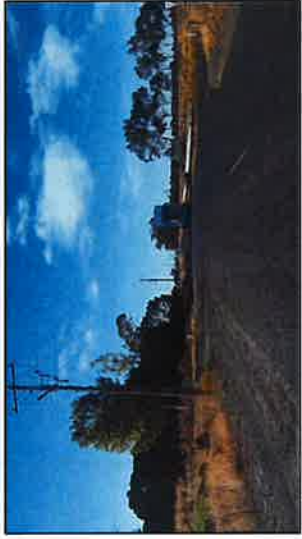
No	Audit Findings	Audit Recommendations	Risk Rating	Accept: Yes / No	Client Response Reasons / Comments
1.4	Markings and Delineation				
1.4.1	<p>Numurkah Road only has a centreline marked in the vicinity of the Spencer Road intersection. At the intersection this centre line is faded.</p>

<p>Edgelines delineate the edge of the road and can discourage traffic from travelling on shoulders. No edgelines are present along Numurkah Road.</p>	Refresh the centre line along Numurkah Road through the intersection and consider the installation of edgelines.	Likelihood: Improbable Severity: Minor Risk Rating: LOW	Yes

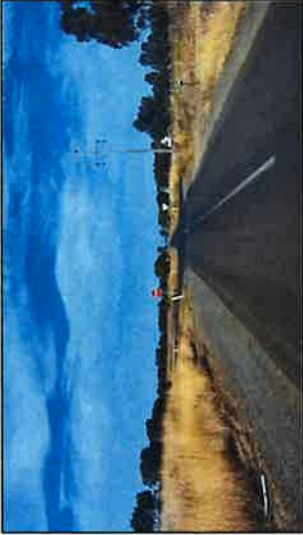
1.4.2	<p>The narrow seal of Spences Road precludes the installation of longitudinal line markings, apart from the single continuous dividing line at the approach to the STATCON markings at each yield point.</p> <p>The single continuous dividing line marking at the intersection is faded, reducing visibility of the intersection, particularly in dark and inclement weather conditions on the western approach.</p>	Refresh the single continuous dividing line to the STATCON markings on the western minor approach.	Likelihood: Improbable Severity: Serious Risk Rating: MEDIUM	Yes

No	Audit Findings	Audit Recommendations	Risk Rating	Accept: Yes / No	Client Response Reasons / Comments
1.4.2 Cont.	<p>This could result in a vehicle on Spences Road misjudging the intersection and overshooting, potentially colliding with through traffic on Numurkah Road.</p>

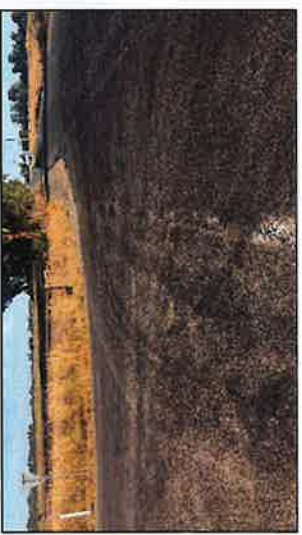
Refer above	Refer above		
1.4.3	<p>Near the intersection along both Spencer Road and Numurkah Road, guideposts are only installed to mark cross culverts and other roadside structures.</p>

<p>Guide posts are used to mark the edge of the road formation in the absence of other features, such as edgelines, guard fence or bridge rail.</p>	Consider installing additional guideposts on the approaches to the Spencer Road/Numurkah Road intersection to enhance delineation of the intersection.	Likelihood: Improbable Severity: Minor Risk Rating: LOW	Yes

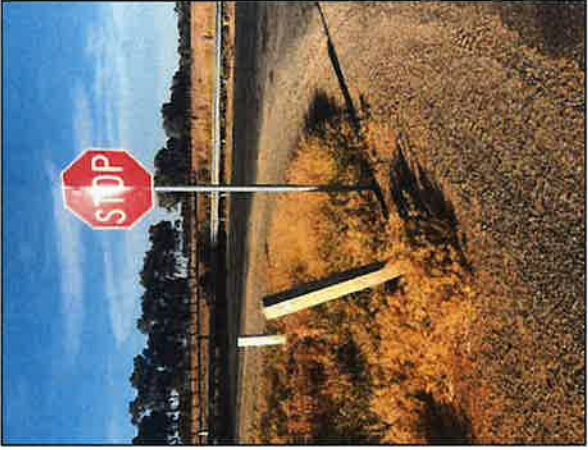
No	Audit Findings	Audit Recommendations	Risk Rating	Accept: Yes / No	Client Response Reasons / Comments
1.4.3 Cont.	Guideposts delineate the road edge and assist the road user by indicating the alignment of the road ahead and under some circumstances, by providing a gauge with which to assess available sight distance.	Refer above	Refer above		
1.5	Crash Barrier and Clear Zones				
1.5.1	<p>Located near the Stop sign on the western approach to Numurkah Road is an obsolete (old style) guidepost. This is not considered frangible and present a hazard to an errant vehicle on the western approach to the intersection.</p>

Remove the obsolete guidepost and replace it with a frangible guidepost as required.	<p>Likelihood: Improbable</p> <p>Severity: Minor</p> <p>Risk Rating: LOW</p>	Yes

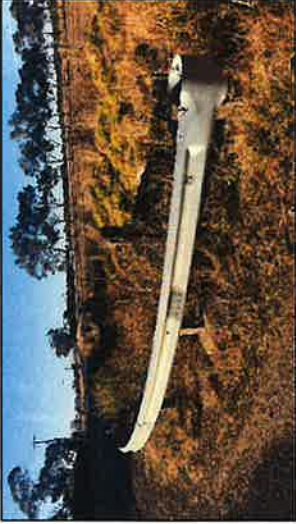
No	Audit Findings	Audit Recommendations	Risk Rating	Accept: Yes / No	Client Response Reasons / Comments
1.5.2	<p>Type-B Guard Fence exists on the north east quadrant of the intersection shielding the farm channel infrastructure.</p> <p>A redundant fence post is located behind the southern barrier terminal.</p>

<p>The existing barrier does not protect the fence post at the location as it is located behind the gating terminal, which provides an inadequate length (of need) for the safety barrier.</p> <p>Should an errant vehicle run-off the road at this location, the barrier will not shield this hazard as intended.</p> <p>The safety barrier installation does not conform to current guidelines.</p>	<p>Consider the following course of action (in order of priority):</p> <ol style="list-style-type: none"> 1. remove the hazard (post) 2. mitigate the residual risk (i.e. shield remaining roadside hazards with a compliant safety barrier system as required, replacing the existing non-conforming system). 	<p>Likelihood: Improbable</p> <p>Severity: Serious</p> <p>Risk Rating: MEDIUM</p>	<p>Yes for guideposts</p>	<p>Action item 2 is subject to further budget considerations</p>

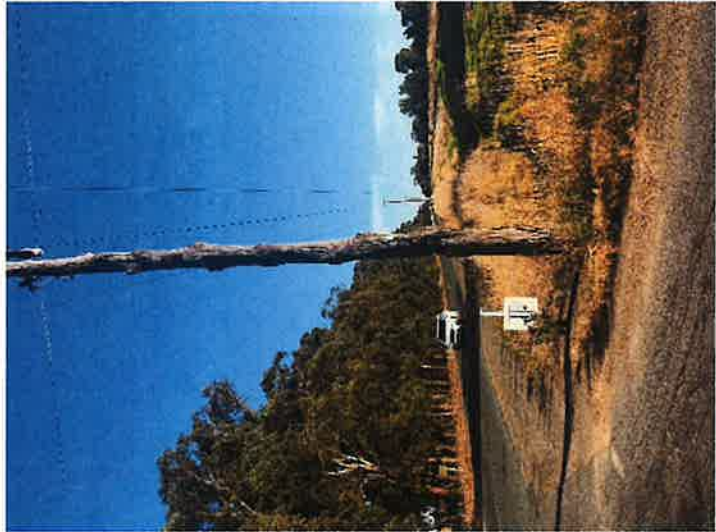
No	Audit Findings	Audit Recommendations	Risk Rating	Accept: Yes / No	Client Response Reasons / Comments
1.5.3	<p>There is a power pole located on the south west quadrant of the intersection, at a 2.2 m offset from the edge of seal.</p>

<p>This is considered a hazard should an errant vehicle run-off the road at this location.</p>	<p>Consider the following course of action (in order of priority):</p> <ol style="list-style-type: none"> remove / relocate the power pole mitigate the residual risk by shielding the pole 	<p>Likelihood: Occasional Severity: Serious Risk Rating: HIGH</p>	<p>No to relocation of guidepost. Yes to providing barrier railing to shield the post subject to future budget availability</p>	<p>The relocation of the power pole is considered too high for Council to fund as it carries power lines in both directions. Council's preference is for the pole to be replaced by Powercor at time of renewal.</p>

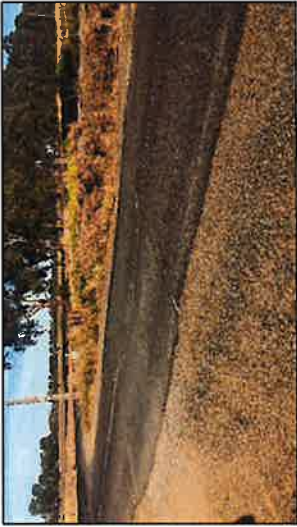
No	Audit Findings	Audit Recommendations	Risk Rating	Accept: Yes / No	Client Response Reasons / Comments
1.6	<p>Pavement</p> <p>It appears the pavement is failing on the western approach to the intersection at the location of the channel crossing/syphon under Spencer Road.</p> <p>This has resulted in a depression occurring in the road formation within the braking zone at the approach to the intersection.</p>

<p>This may cause an approaching eastbound vehicle to lose control, or impede the braking ability, resulting in a collision with a road side hazard or another vehicle at the intersection.</p> <p>It should be noted that there was evidence of maintenance spray paint reference markings on the road pavement at the depression, potentially indicating an intention to address this pavement depression.</p>	<p>Repair the road pavement.</p>	<p>Likelihood: Occasional</p> <p>Severity: Serious</p> <p>Risk Rating: HIGH</p>	<p>Yes</p>
