Thank you for your email of 7 December 2021 with accompanying cover letter and Her Honour Coroner Magistrate Audrey Jamieson's Finding (the report) dated 6 December 2021, reference **COR 2018 004310**, without inquest into the death of Mrs Ingeburg Muller on 28 August 2018.

Marquis Street/High Street, Ashburton
Threshold Treatment
Existing Conditions Stage Road Safety Audit

Prepared for: City of Boroondara
Project Ref: TS-22-RSA-5715A
Date: 14 February

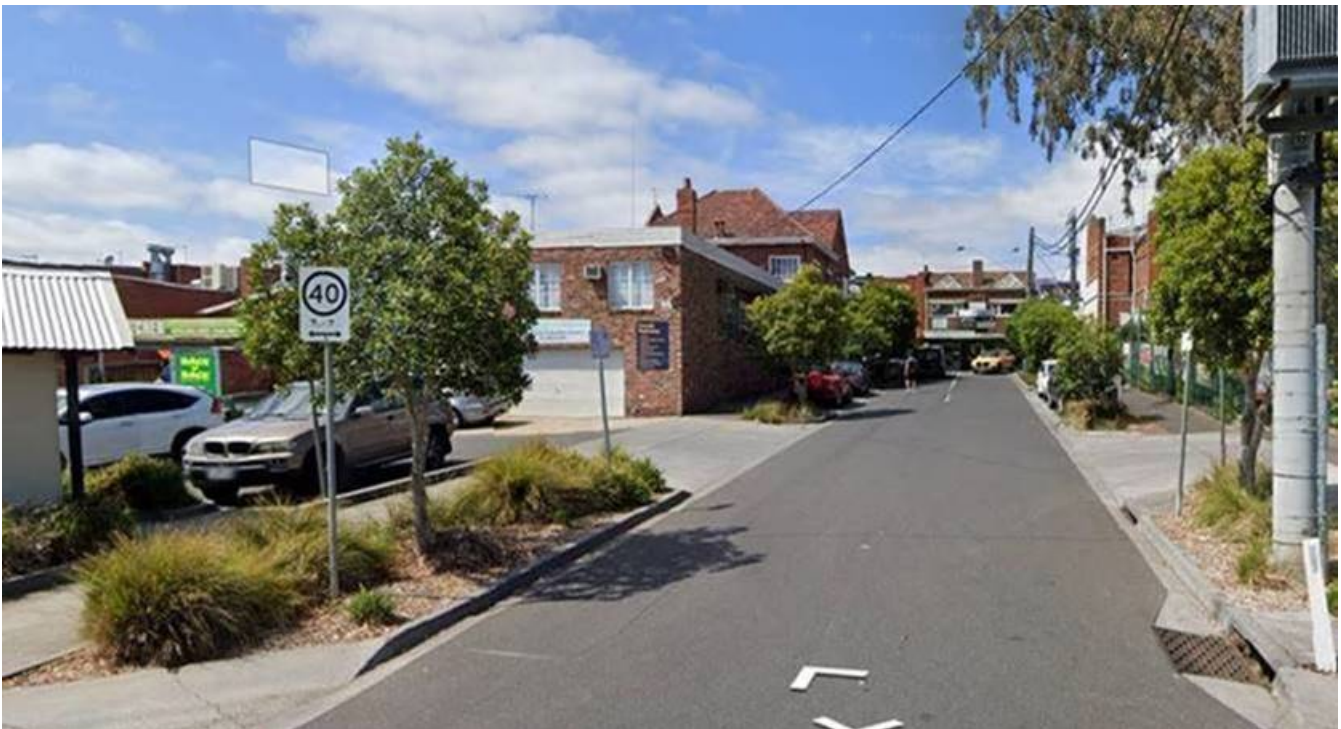
With respect to item 58, It should refer to the southbound lane and the sign in question is associated with the 40 km/h High Street shopping strip speed limit. The Coroner is recommending signage consistent with the Road Design Notes.

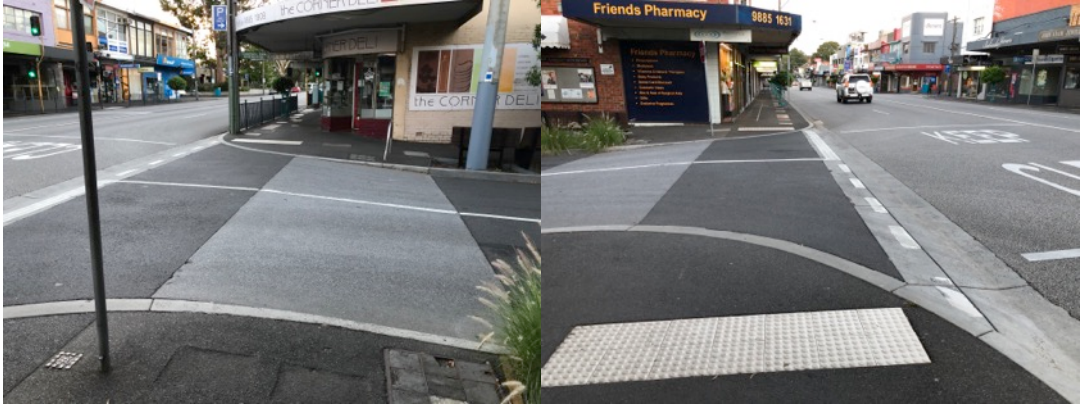
10.1	<p>The threshold treatment raised surface (where pedestrians cross) is asphalt, which is the same as the road surface on both Marquis Street and High Street. The threshold treatment has reduced conspicuity/inadequate contrast with only a concrete channel on the High Street side and a grey ramp/transition on the northern side. The threshold treatment should have greater contrast for the raised section/crossing with an alternative surface to asphalt to highlight its presence. Notwithstanding, current road rules dictate that all road users turning into Marquis Street must give way to pedestrians crossing the road, while pedestrian crossing must give-way to traffic travelling south on Marquis Street. However, it is often the case that motorists travelling south to a T-intersection will give-way to a pedestrian crossing.</p>

Medium	
Likelihood Unlikely, Severity Moderate (based on Car vs Ped at <10km/h) = Risk is Medium

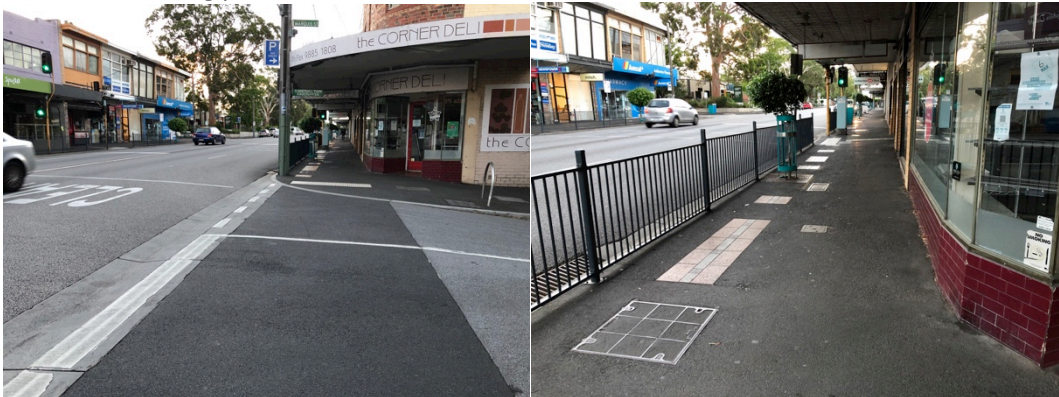
10.2	<p>Sight lines from Marquis Street to the west are restricted by the pedestrian fencing located on the northern side of High Street, to the west of Marquis Street. When viewed from a low angle, the fence is difficult to see through and creates a near solid visual obstruction. For motorists to safely pick a gap in traffic and also observe more vulnerable road users (e.g. cyclists, motorcyclists/scooters, etc.), clear sight lines to/from the intersection should be achieved. It is acknowledge that the fence is installed to prevent pedestrians from crossing High Street away for the pedestrian operated signals, however it comprises the ability of motorists to see on-coming traffic and crossing pedestrians.</p>

<p>Likelihood Possible, Severity Moderate (side impact car vs car and Car vs Ped at <10km/h) = Risk is High/High (FSI) depending on operating speed and/or vulnerable road user</p>	High / High (FSI)

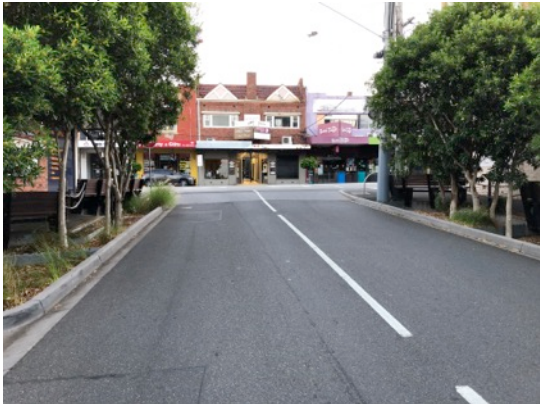
10.4	<p>Sight lines from the Marquis Street southbound approach to the threshold treatment/raised crossing are partially obscured by trees/vegetation. This may be exacerbated by the position of the seating which in busy periods may have groups of pedestrian that could limit visibility to/from pedestrians about to cross from the east to west.</p>

<p>Likelihood Rare, Severity Moderate (based on Car vs Ped at $<10\text{km/h}$) = Risk is Low</p>	Low

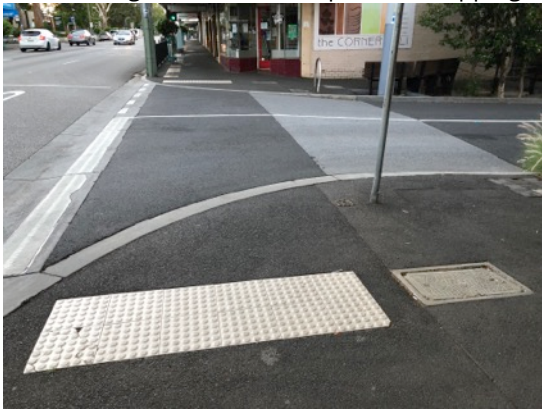
Marquis Street at High Street, Ashburton – Threshold Treatment Existing Conditions Stage Road Safety Audit			
Item	Finding and Commentary / Recommendation	Ranking	Project Team/Client Response
			Accept Yes/No
10.6	<p>There are some pits and or other features within the footpath that are not flush with the surrounding surface and are potential tripping hazards.</p>

<p>Likelihood Possible, Severity Insignificant (pedestrian trips over) = Risk is Low</p>	Low	
10.7	<p>There is an edge drop from the pedestrian area on the western side of Marquis Street near the seating and bicycle lock up hoop. The level difference is a potential tripping hazard.</p>

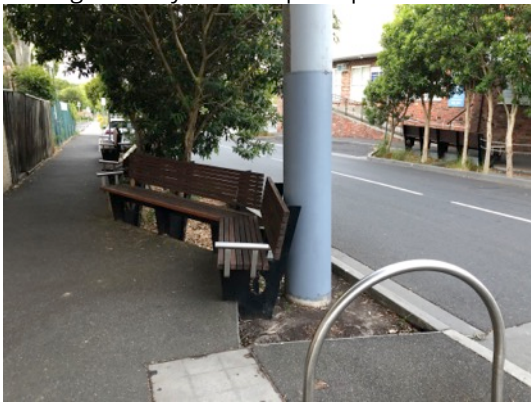
<p>Likelihood Possible, Severity Insignificant (pedestrian trips over) = Risk is Low</p>	Low

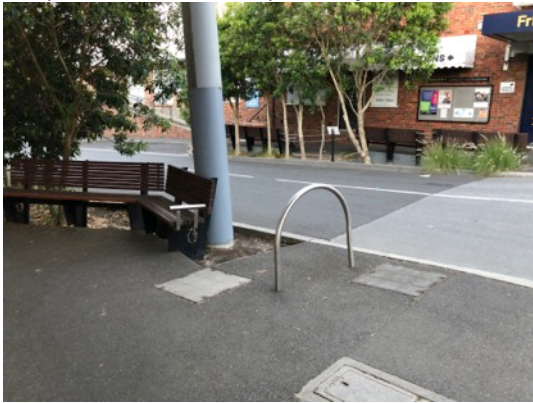
10.8	<p>The bicycle lock up hoop is located at back of kerb and bicycles parked may encroach into the roadway. There is potential for bicycles close to the road to be struck by a vehicle. The bicycle hoop should be able to park bicycles clear of the kerb and road.</p>

Low		
	Likelihood Possible, Severity Insignificant (property damage) = Risk is Low

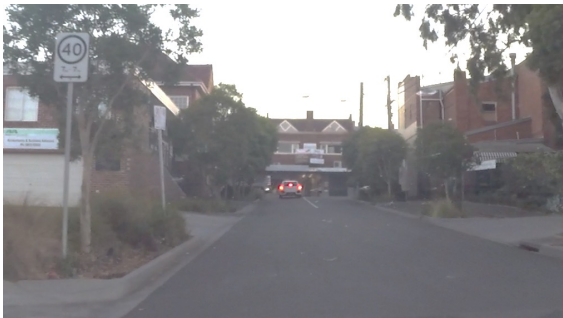
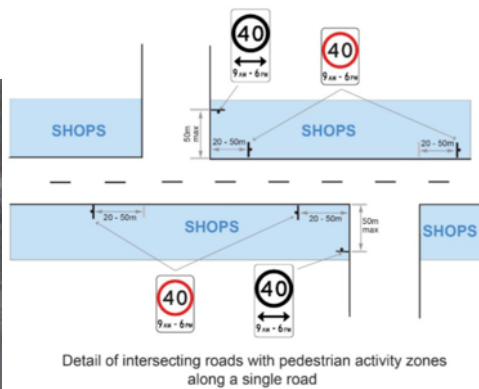
Item	Finding and Commentary / Recommendation	Ranking	Project Team/Client Response	
			Accept Yes/No	Reasons/Comments
10.11	<p>Recommendation (no 58)</p> <p><i>“With the aim of promoting public health and safety and preventing like deaths, I recommend that Boroondara City Council replace the existing advisory speed limit sign of 40 kilometres per hour between the hours of 7.00am to 7.00pm along the northbound lane of Marquis Street to a warning sign of ‘Raised Intersection’ with advisory speed limit of 40 kilometres per hour.”</i></p> <p>Response – The 40km/h advisory speed limit sign on Marquis Street is consistent with DoT guidelines (TEM Vol 3 Part 211 Speed Zoning Guidelines Dec 2021) for signing of activity centres speed zones (i.e. the 40km/h speed limit on High Street). As such the current advisory 40km/h 7am – 7pm should remain.</p>	NA
