# CASE STUDY

## MILL PARK FIRE FATALITY 2019

PERFORMANCE AND ASSURANCE UNIT  
STATE OPERATIONS DEPARTMENT  
OFFICE OF THE FIRE RESCUE COMMISSIONER

APRIL 2024

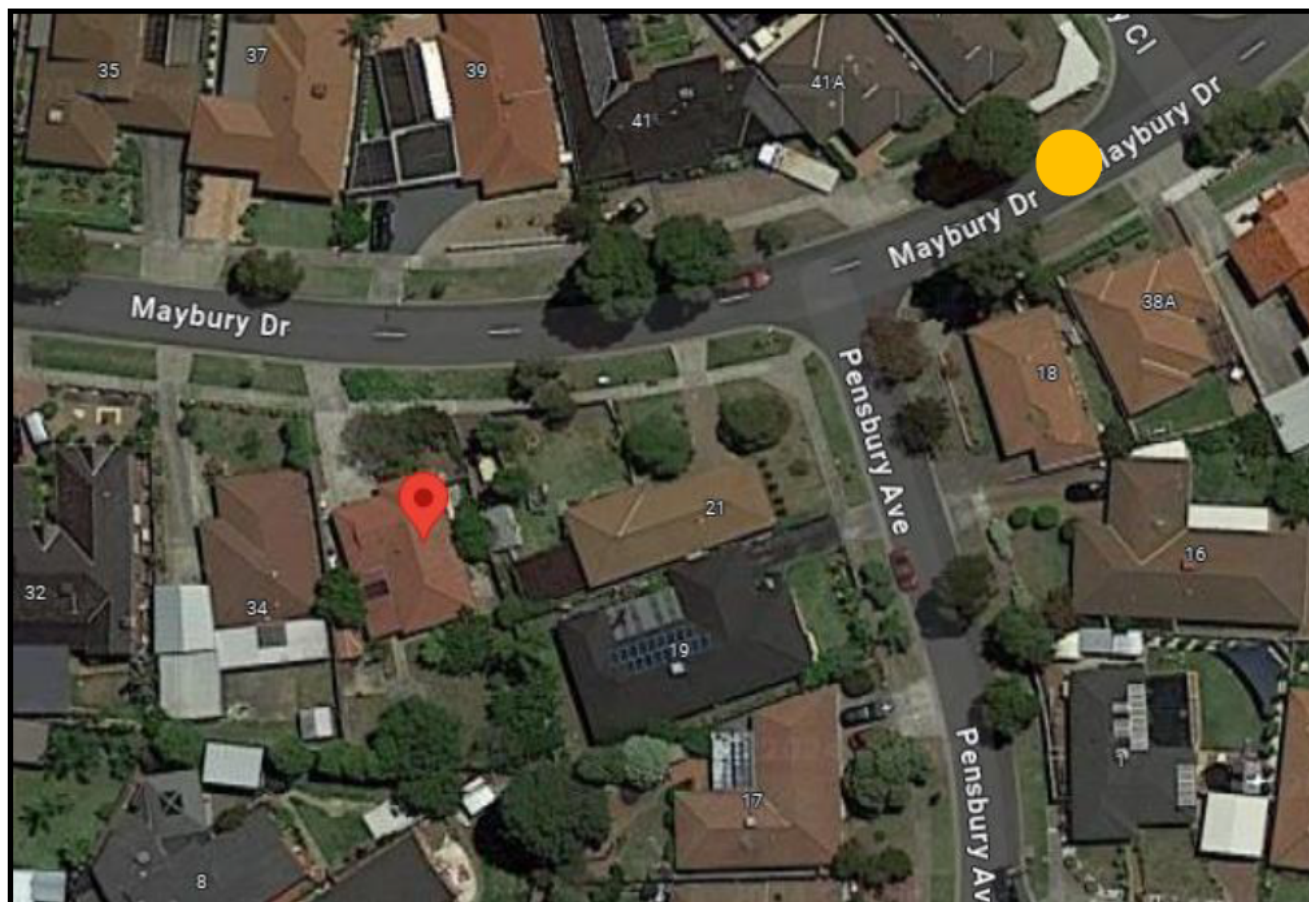
At 3.31am, the first fire appliance booked on scene. They passed properties at number 40 and number 38 before stopping at the house next door, believing it to be 36 Maybury Drive. It was, in fact, 38A Maybury Drive. This house was on the corner of Maybury Drive and Pensbury Avenue, and its letterbox was damaged, so the number 8 was not visible.

The number 38A was stencilled on the curb next to the driveway of the property being investigated, and it was also attached to a post on the front patio, but neither was seen by the crews during their investigation.

Figure 1: 36 Maybury Drive, Mill Park (identified with a pin drop) and where MFB appliances staged for its first firecall to Maybury Drive (indicated with a yellow circle), believing they were at the correct address.

The investigation also established that the attending crews for the first call to Maybury Drive did not take adequate steps to correctly identify the address when speaking to the residents at the property on Maybury Drive by asking them to confirm their address. Further, crews did not notice the number 38A on the patio post when approaching the front door of this residence. When MFB/CFA walked past 36 Maybury Drive, the number was clearly on the letterbox at that address but was not noticed or communicated by the firefighter.

- Thorough size-up of the location, including investigation of letterboxes, street curb marking, and pole markings.
- Questioning residents at the nominated address and asking them to confirm their address.
- Requesting the caller details and contacting with the original caller or asking Firecom (communications centre) to contact the caller to verify the address.
- To understand that street numbers are not always sequential, and that confirmation of the street numbering pattern is required.
- For the OIC to communicate the importance of address verification to crew, and for crew to assist with size-up and share intelligence.
- To allow sufficient time for accurate size-up and intelligence gathering.
- Communicating to Firecom all steps that have been taken to confirm the address before providing a 'returning' Wordback.
