IN THE CORONERS COURT  
OF VICTORIA  
AT MELBOURNE

**COR 2018 002995**

**FINDING INTO DEATH WITHOUT INQUEST**

| Keywords: | Workplace injury, accidental death, piling rig, auxiliary line, headstrike, industry standards |

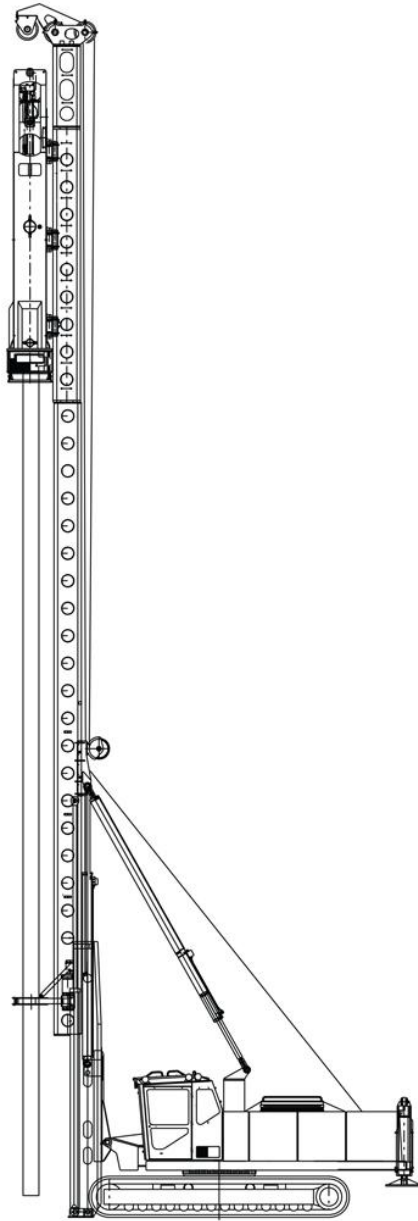
*Figure 1: Junttan Piling Rig Model PM 25H*

5. The piles are driven into the ground by machine known as a '*piling rig*'. The machine is on tracks, similar to a tank, and using a hydraulic-powered hammer, drills into the ground. The piling rig has an auxiliary line (also known as a whip line), made of rope or cable, and which serves to assist the main winch in lifting and manipulating equipment and materials on the rig. The end of the auxiliary line can be fitted with different apparatus (depending on the circumstances) and in this instance, it was fitted with a hook. For the Project, Wagstaff used two identical piling rigs from Junttan Oy Pty (**Junttan**) Ltd and which were delivered in May 2018.<sup>1</sup> The piling rig appears as below, obtained from Junttan directly:
