IN THE CORONERS COURT
OF VICTORIA
AT MELBOURNE

FINDING INTO DEATH WITHOUT INQUEST

Deceased: Sanel Mujezinovic

Cause of death: 1a: Multiple injuries sustained in a workplace incident

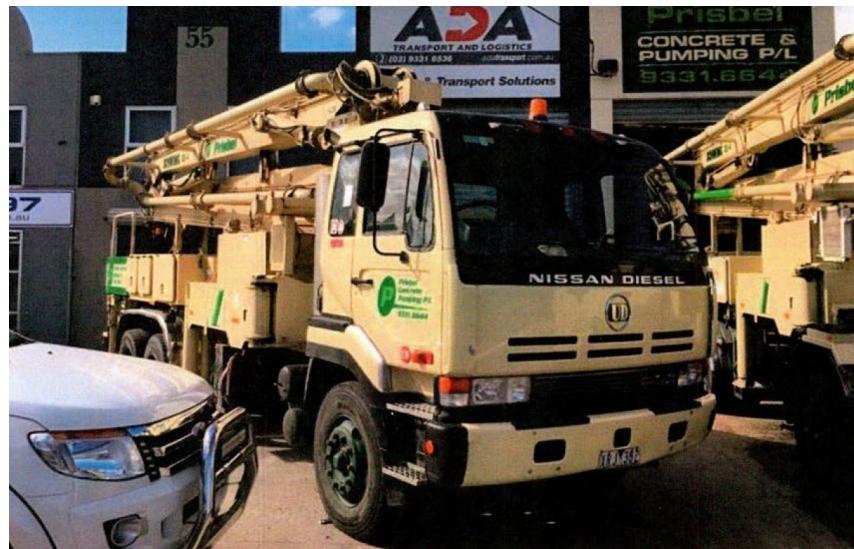
Photo of pumping truck taken during 2018 annual inspection.

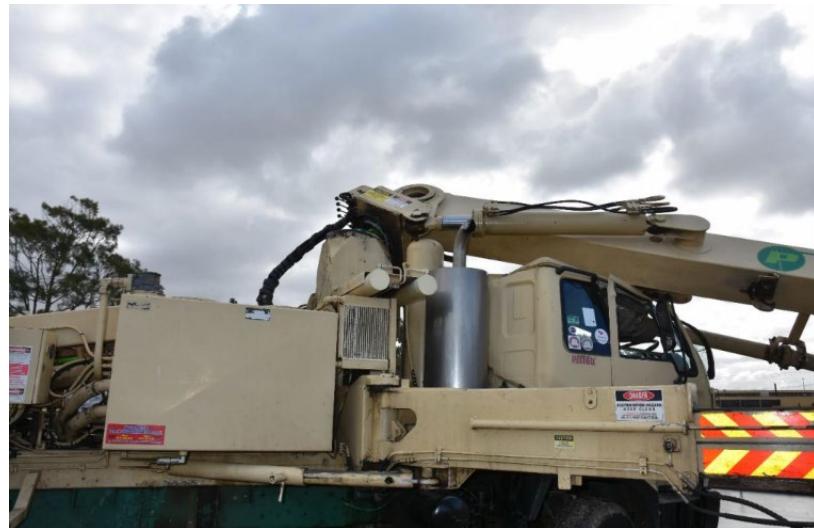
26. Following Sanel's death, WorkSafe Victoria (**WorkSafe**) conducted an independent investigation into the incident.
27. The investigation identified that the boom's collapse was due to a metal fatigue crack in the king post. The king post is an internal component of the turret assembly at the base of the concrete boom, which connects the boom to the truck. The king post is a steel cylinder that

holds the boom upright and enables the boom to rotate (or slew), supporting its weight as concrete is pumped through the boom.

Photo of the snapped king post taken following its collapse.

28. Subject matter expert, investigation engineer Barry Gartner, opined that the fatigue cracking probably took several years to develop before a crack had initiated. He considered that the presence of the fatigue cracking would have been detectable possibly months before the final fracture, and the slow propagation primary fatigue crack zones may have been detectable for a year or more. However, the ability to detect those primary cracks would require accessibility to the king post.

1. Sanel Mujezinovic died from injuries sustained when struck by a concrete placing boom that collapsed in a workplace incident. The boom’s catastrophic collapse resulted from fatigue cracking that developed and propagated through the boom’s king post over a long period of time, likely a number of years.

2. To detect the fatigue cracking that resulted in the boom collapse, a strip-down inspection involving disassembly of the boom's base (the turret) would have been required to access and test the king post. There is no evidence that any such strip-down inspection ever occurred during the 30-year life of the concrete boom.

- (ii) In the process of revising and updating the *Concrete Pumping Industry Standard* 2004, I recommend that WorkSafe Victoria give consideration to introducing more stringent requirements for strip-down inspection of concrete pumps (whether within the Industry Standard or by issuing a Compliance Code, Code of Practice or other industry guidance document) to improve identification of issues with internal components before they cause catastrophic malfunction and death.
