IN THE CORONERS COURT  
OF VICTORIA  
AT MELBOURNE

**FINDING INTO DEATHS AFTER HAVING HELD AN INQUEST**

Deceased: **MAXWELL QUARTERMAIN** (COR 2017 0872)  
**GREG DE HAVEN** (COR 2017 0873)  
**GLENN GARLAND** (COR 2017 0874)  
**JOHN WASHBURN** (COR 2017 0875)  
**RUSSELL MUNSCH** (COR 2017 0876)

‘Air-crash’, ‘Civil Aviation Safety Authority’,  
‘Australian Transport Safety Bureau’, ‘Essendon  
Airport’, ‘Checklist’, ‘Beechcraft King Air B200’.

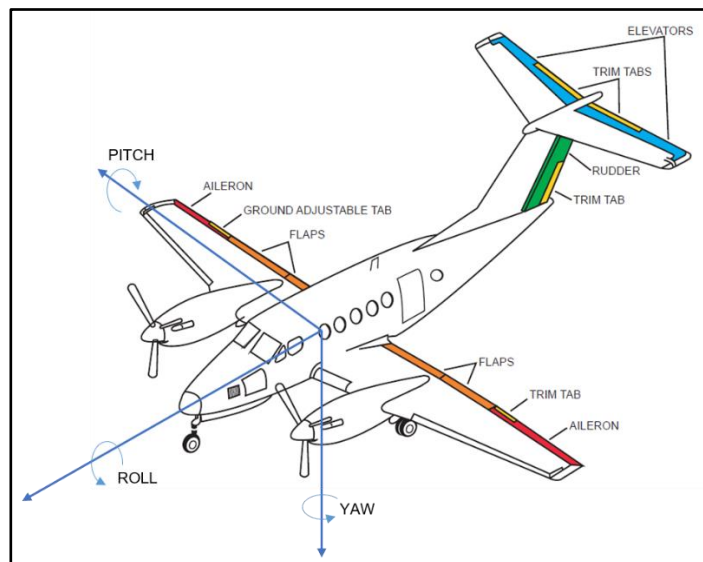
95. Mr Nishizawa was shown figure 3 in the ATSB Report, here reproduced:

Mr Nishizawa gave evidence that the rudder trim tab was about 1 meter top to bottom and that if it was in full left or right position, it would be a relatively large deflection angle for this kind of aircraft, would be about 3 inches off the centre instead of sitting neutrally aligned to the rudder, and if you were to walk around the aircraft with the trim tab in full deflection, it would be obvious.

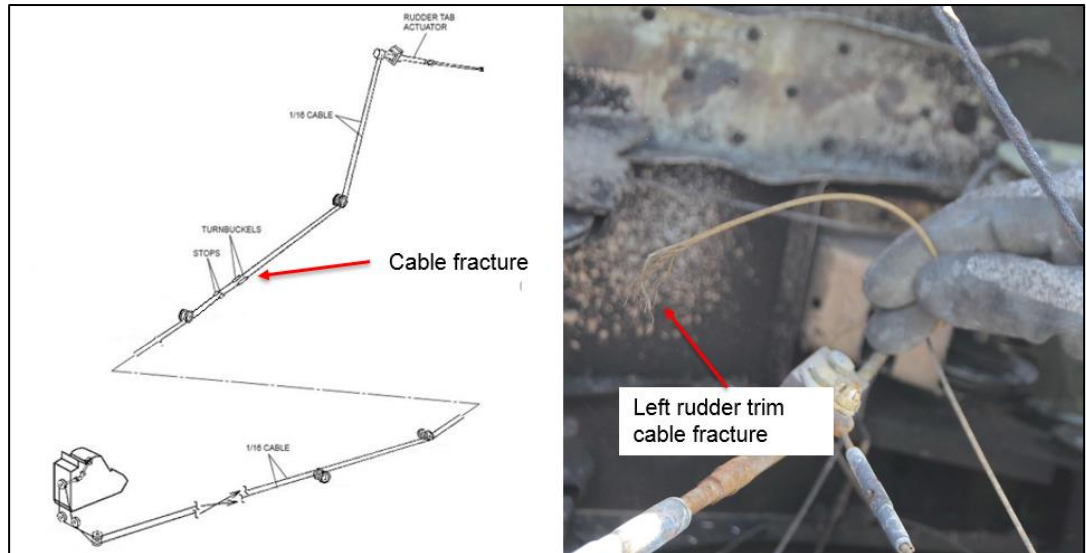
- (c) In order to turn the rudder trim to ‘full nose-left’ position from a neutral position, you would have to turn the trim wheel in the cockpit to the left through 180° approximately three times to get the full travel.<sup>98</sup>

- (d) He determined with reference to a number of contributing factors that the Aircraft’s rudder trim was likely in the position of ‘full nose-left’ at the *commencement of take-off*,<sup>99</sup> such factors including:

- (i) photographs of the crash site which showed abrasion marks and compressed damage were present on the right side of the rudder and the rudder trim tab indicated that the area made contact with a hard flat abrasive surface. The abrasion damage indicated that the rudder trim tab was positioned to the right of the rudder surface during the impact sequence;<sup>100</sup>

- (ii) when the rudder trim tab is moved to the right, it will have an effect on the rudder assembly which will move the entire rudder assembly to the left. The effect on the aircraft of moving the rudder assembly to the left is to move the nose of the aircraft about its vertical axis to the left. The abrasion marks observed during inspection the displacement indicated that the rudder trim was in a ‘full nose-left’ position at impact. An analysis of the roof impact marks and CCTV footage showed the aircraft at

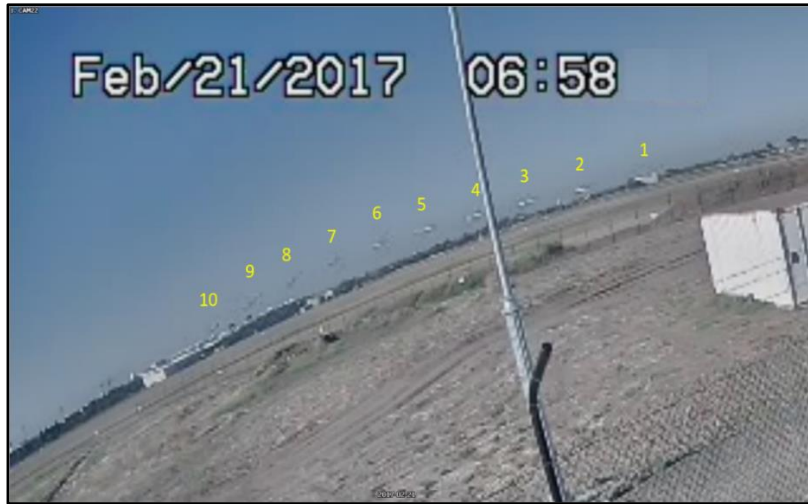
121. Using actual time lapse CCTV footage ATSB has produced figure 23 (reproduced below) which provided an indicative depiction of the Aircraft's vertical flight path. The substantial sideslip was first observed at point six on the image. At this point the Aircraft transitioned from a climb to a descent.

*So following the onset of the sideslip ZCR began a descent followed by the collision with the outlet centre building. The data also showed an increase divergence of the runway centre line when airborne and reduction in rate of climb and airspeed following the commencement of the sideslip. This was consistent with the theoretical effects of a substantial left sideslip on the aircraft's performance.*

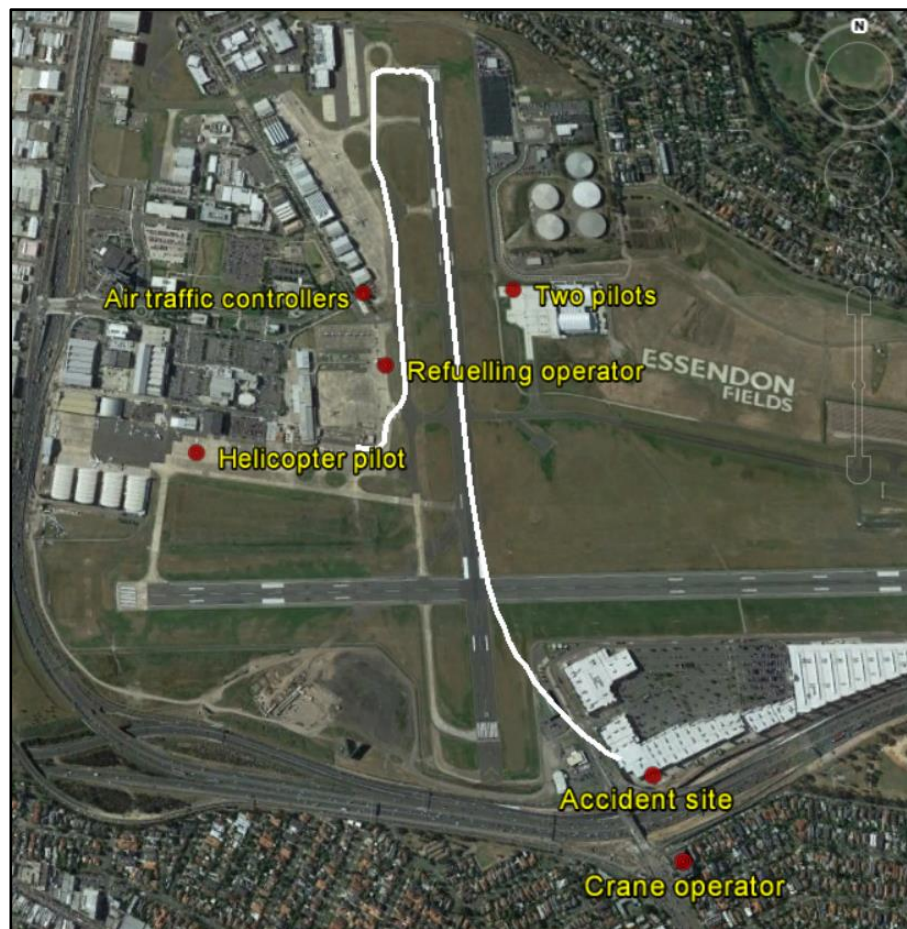
129. From where the Aircraft was parked, to the commencement of the runway from which it took off, there was no reason to manipulate the rudder trim control.
130. In relation to any control mechanism that is close to the rudder trim tab control mechanism that might be similar in physical appearance or style and would need to be utilised before the aircraft became airborne, the only mechanism would be the aileron trim and Mr Hoffmeister gave evidence that he did not believe that there would be any reason to operate the aileron before the aircraft became airborne.<sup>122</sup>
131. With reference to figure 13 in the ATSB Report and cross-referenced to table 3 which contained each of the checks of the rudder trim that ought to have been provided pursuant to the manufacturer's checklist, Mr Hoffmeister charted where each of the checks ought to have been performed (see image below).
