IN THE CORONERS COURT OF VICTORIA AT MELBOURNE COR 2023 000077

FINDING INTO DEATH WITHOUT INQUEST

Findings of:	Coroner Ingrid Giles
Deceased:	Mark Brian Lowther
Date of birth:	3 May 1966
Date of death:	4 January 2023
Cause of death:	1a: HEAD INJURIES
Place of death:	63 Ennismore Crescent, Park Orchards, Victoria, 3114
Keywords:	Accidental death, DIY, at-home work, tree felling, excavator, chainsaw

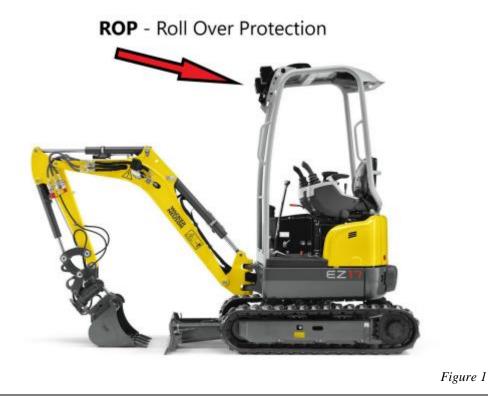
29. ROPs form an important safety component of all excavators. ROPs can be an enclosed cabin, or open metal frame, which surrounds the driver's seat. ROPs protect the operator in the event that the machine rolls over, as well as providing protection against falling objects. The ROP on a Track Excavator EZ17 (E13-01) appears as follows in Figure 1:

- 30. The ROP from Mark's excavator could not be located by Victoria Police on the day of his death. However, Emma confirmed to SC Slater that a ROP did exist, but that it had *'recently been refitted by a family friend who had borrowed the excavator'*.
- 31. It was therefore posited by SC Slater that the ROP had been removed by Mark at some point prior to his attempt to fell the tree. As a consequence, the operator's seat was left exposed to any falling objects and Mark was left with no protection when the tree came down towards him.

- 41. I find that Mark Brian Lowther attempted to cut down the tree despite that the safety apparatus of the excavator had been removed, which was against the manufacturer's advice, and as a result, placed him at an appreciable risk of being seriously injured or killed by falling objects.
